Upper Camshaft Chain Guide Facing Failures

Marc Haibeck

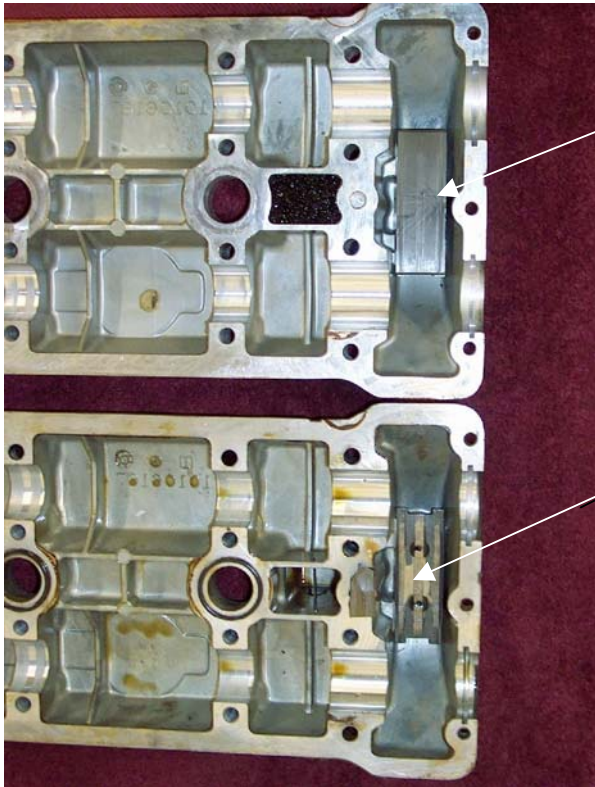
This is the plastic guide facing. It clips onto a metal holder strip. It shows normal wear from the chain's occasional contact with it.

Here the guide facing has detached and the chain has been making abrasive contact with the metal holder strip. Note the grooves that are also cut into the two black fasteners.

The facing is normally located about 3 mm above the top of the chain. A major problem occurs when the facing is not present. The space above the chain is about 8 mm which is approximately the thickness of the chain. Then the chain can snag in the gap and break.

After the tab breaks off, for a short time, the facing will float around on top of the chain. It may be observed hanging off toward the front of the engine. If the engine continues to be run the facing will get abraded by the chain, or the chain can get stuck in the space between the tops of the sprockets and the cover. With more operation the chain may tear the holder off of the camshaft cover, it can go into mesh with the sprockets and break the chain.

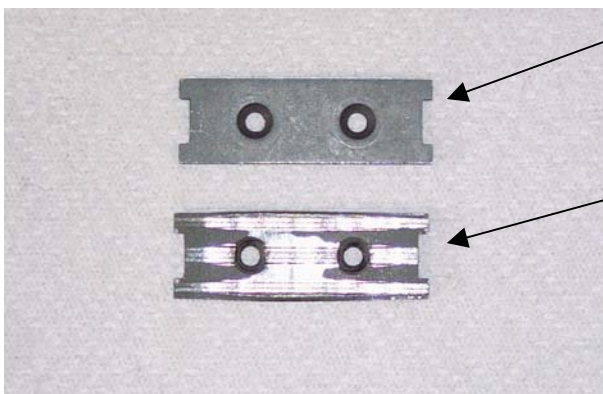
This is the normal look of the facing holder.

This is a holder that ran without the facing.

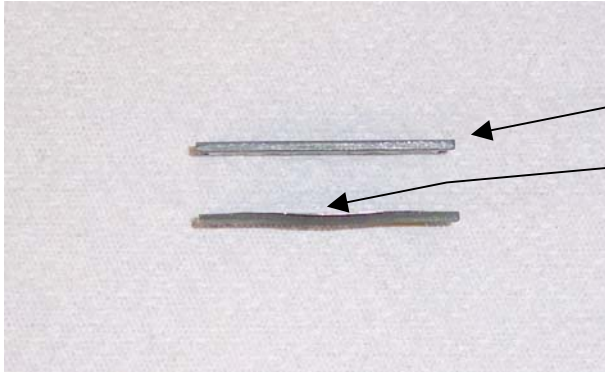
This is a side view of the holders shown above.

The normal one is straight.

The one that ran without the facing has deformed in the center between the fasteners due to the abrasive contact and high pressure. The chain is even more likely to get captured in this cupped area.

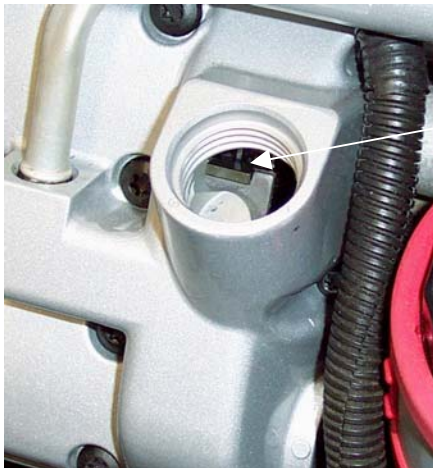
Plastic retainer tab.

The right facing is easy to observe, it can be seen under the oil filler cap. Normally the top edge of the facing's retainer tab can be seen.

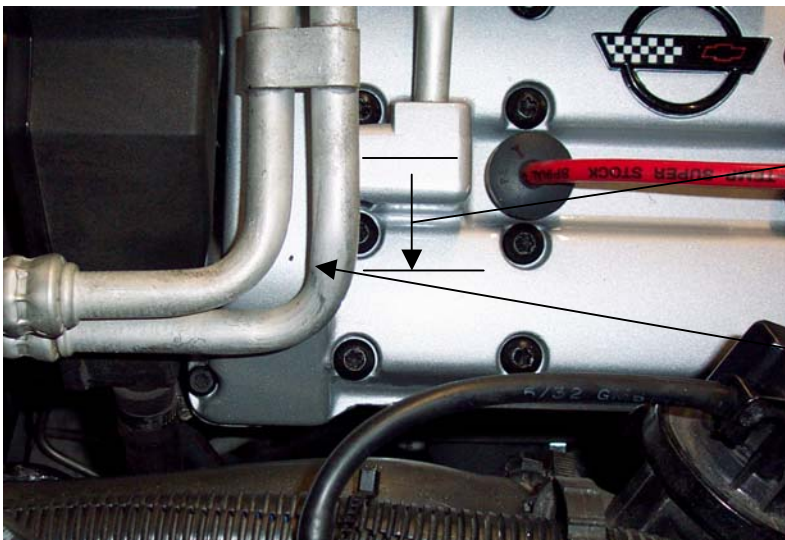
36 mm below the centerline of the camshaft cover.

Drill here, where the dot is marked.

The left facing can be inspected by drilling a .161" hole and inserting a small lamp into the hole. The hole should be located 36 mm below the centerline of the camshaft cover.

Fill the hole with a 1 1/64" self tapping screw with a dab of sealer.
