## **When Giving More Than 100 Percent is a Problem**

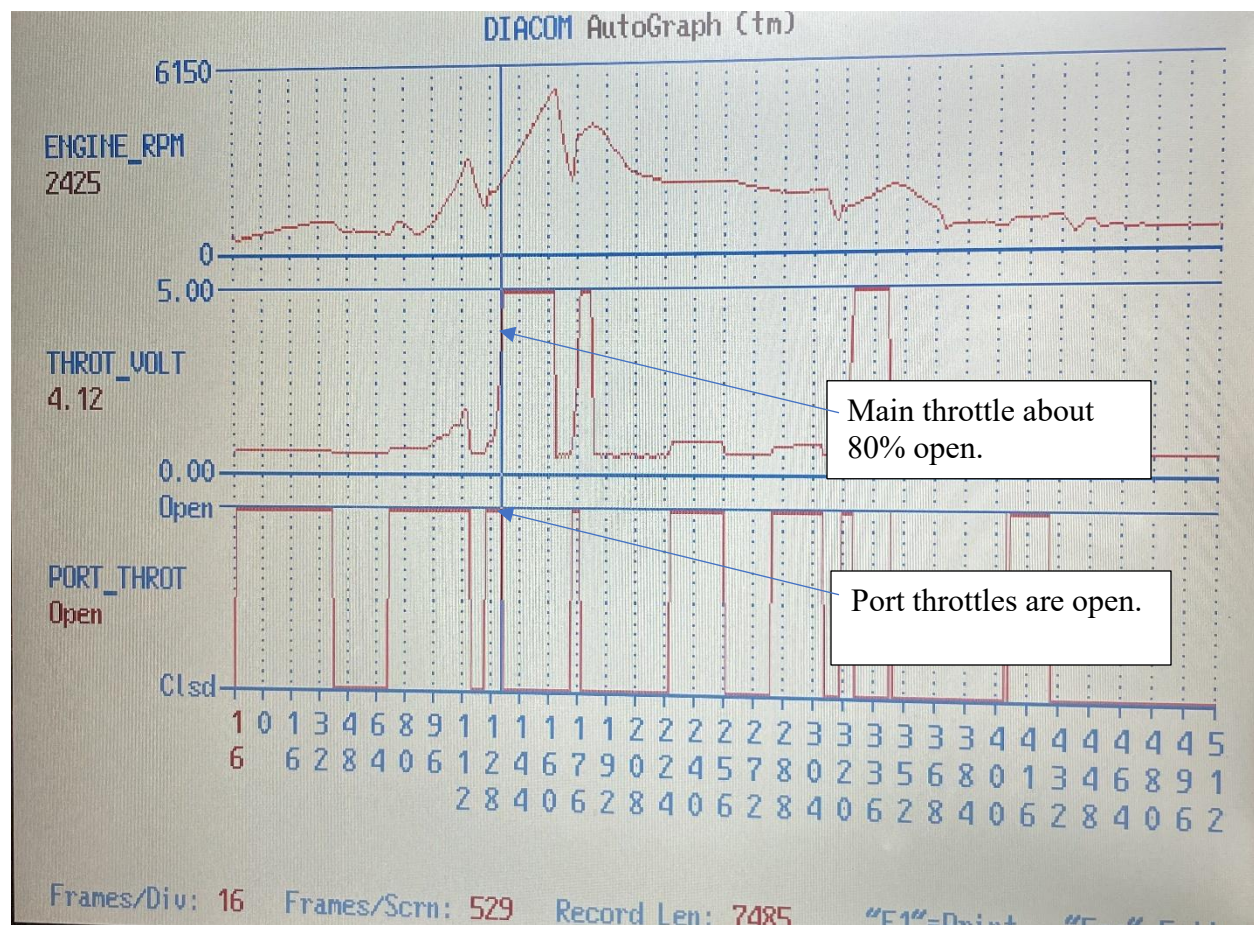
This chart shows the engine running normally, one data frame before the fault occurs.

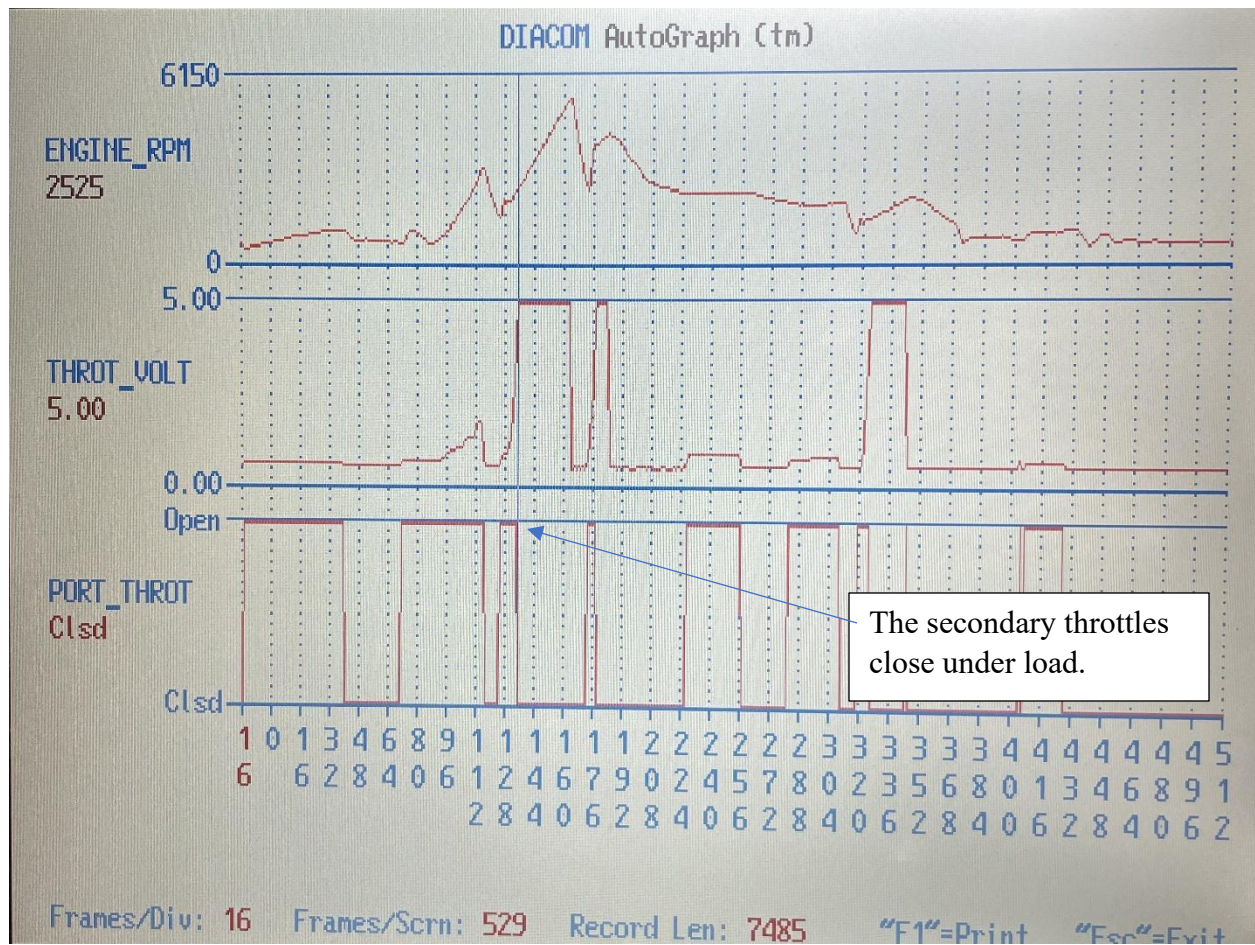
Data was collected with an engine data scanner while driving at full throttle. It was the easy to see that the secondary port throttles were closing when they should stay open. The second data collection chart below shows that the throttle position is going beyond 100% and coincidental with that the secondary port throttles are closing. Since the secondary intake port throttles have been removed from this engine, what was also happening is that the secondary fuel injectors were turning off and the engine was running lean for fuel.

The problem was caused by throttle position sensor voltage that was too high. The engine control system expects to see about 4.65 volts at full throttle indicating a 100% open main throttle. The chart shows the throttle position percent going to 12% when the throttle is opened beyond 4.8 volts. The program can't handle this and it turns off the secondary intake port fuel when the main throttle is fully open. The secondary intake port fuel injectors would remain off until the engine was restarted. Then once again the engine would run normally until the main throttle was opened more than about 60%.

The next chart shows the driver's throttle about 100% open and the secondary throttles have closed. This causes a 50% reduction in fuel. The throttle position sensor voltage over 4.8 volts causes the control program to malfunction.

With a replacement sensor observe the full throttle voltage. It must be less than 4.8 volt. If greater than 4.8, adjust it to 4.7. Use -.1 volt as a margin for reliability. Then observe the closed throttle voltage. It must be greater than .23 volt or the system will set an error 22 for throttle position voltage too low. The throttle position percentage is recalibrated when the ignition is turned off and then back on. A voltage between .24 and .59 volts will display as 0% throttle opening on a scanner. The engine control system stays awake for 10 seconds when the ignition key is turned off. The ignition must be turned off for more than 10 seconds to recalibrate the throttle position sensor position. Turn on the ignition again and check that the TPS position is 0%.

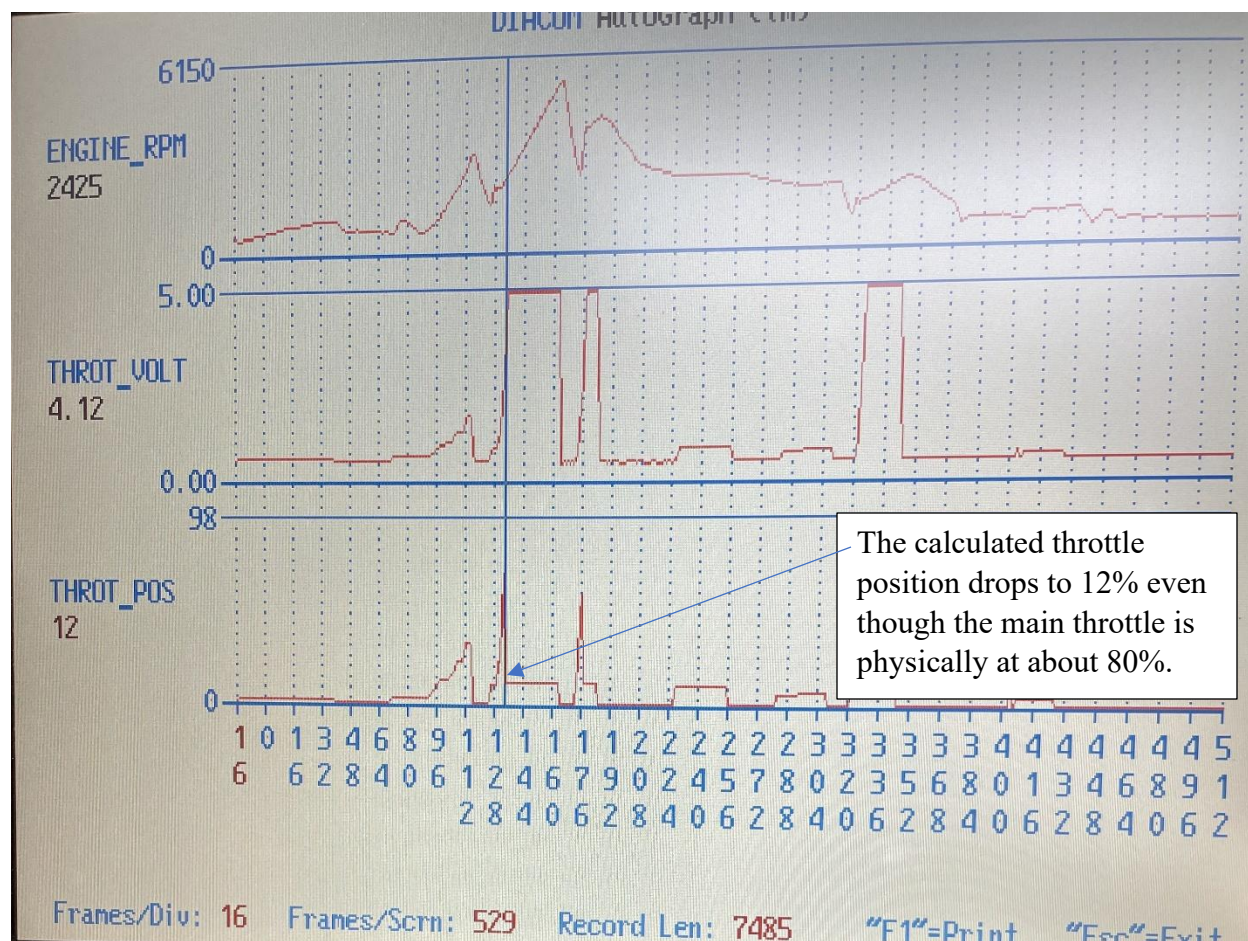
The next chart shows the throttle position opening in percent rolling over from 100% to 12% in one step. The control program can't handle this.
