Are The Secondaries Working?

Marc Haibeck

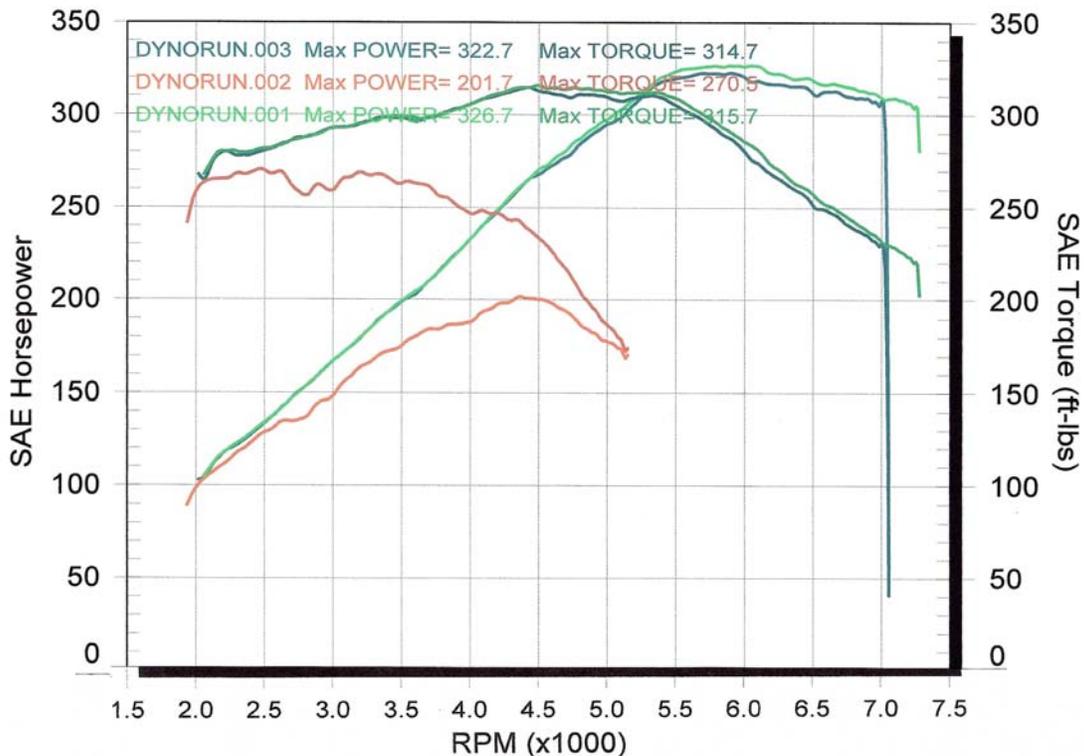
The secondary intake port throttles will open at any engine speed, even 900 rpm when the main throttle is opened 100%. If accelerating below 4000 rpm it might be difficult to judge if the secondary ports are opening. However, the chart shows that without the secondary ports power drops sharply after 4400 rpm.

The chart is for a stock '91 with a Borla exhaust system.

Red: Full Power key off. Green: Full Power key on.

201.7 Dynojet wheel hp / .85 (15% drive line loss factor) = 237 crankshaft hp.

326.7 Dynojet wheel hp / .85 (15% drive line loss factor) = 384 crankshaft hp.

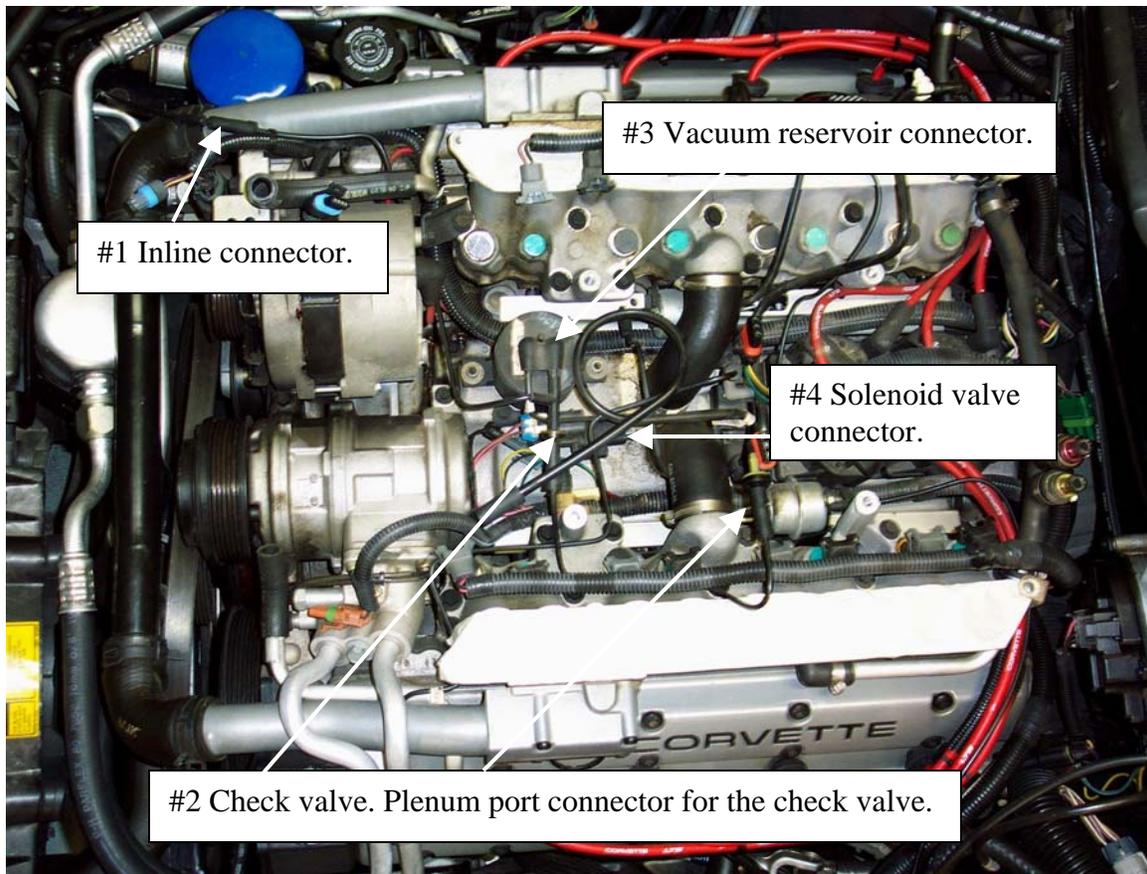
Divide and conquer. If the vacuum pump runs too long the leak is in the area up to and including the secondary vacuum solenoid valve. The top two causes can be found without removing the plenum. Number 1, the inline connector. It can get disconnected during other engine service or during engine cleaning. Number 2, the vacuum check valve. Remove the vacuum fitting at the left center of the plenum and block the rubber fitting with a finger. If the pump cycles off longer the check valve is leaking. The valve can be replaced under the plenum, or a temporary external valve can be hung in series with the rubber fitting and the plenum fitting. Possible leak Number 3 is under the plenum, the vacuum reservoir connector. Wiggle the connection and see how the pump run time is affected. Leak Number 4 is the solenoid valve. To isolate it, remove the connector from the valve and block the vacuum port on the right side with a finger. The pump's off time will increase if the valve is leaking.
