The Low Tire Pressure Warning System

Marc Haibeck

Version 2. 8-Mar-20

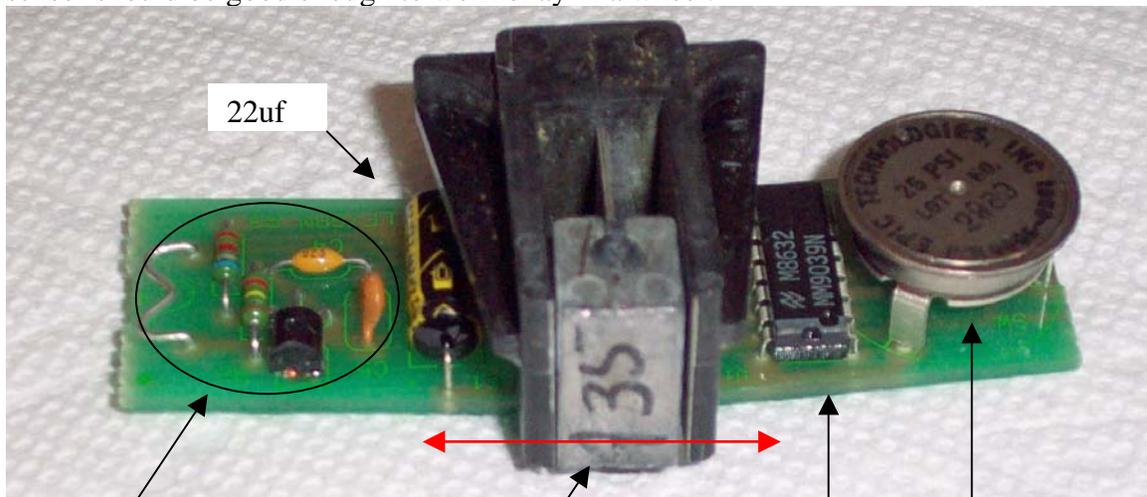
The piezo generator is the number one cause of sensor failure. The piezo panel develops a crack and the voltage output drops off. A very good sensor develops 1 volt AC into the bridge rectifier and 3 volts DC across the 22 uf filter capacitor in the power supply.

RF Transmitter. The piezo armature vibrates in the gap.
The M9039N chip is the same on all sensors.
The wheel selection is made by grounding select lines on the chip.
A bridge rectifier is located under the click switch.

25 psi click switch.

Sometimes the pressure click switch fails and sets a false low tire pressure display. A switch from a sensor with a failed piezo generator can be harvested to repair the sensor.

After a repair the sensor can be tested by simply sitting in the car with the ignition key on and tapping the sensor gently with a screwdriver handle. A very good sensor will turn on the Low Tire Pressure light within 20 seconds. If the light goes on within 60 seconds the sensor should be good enough to work okay in a wheel.

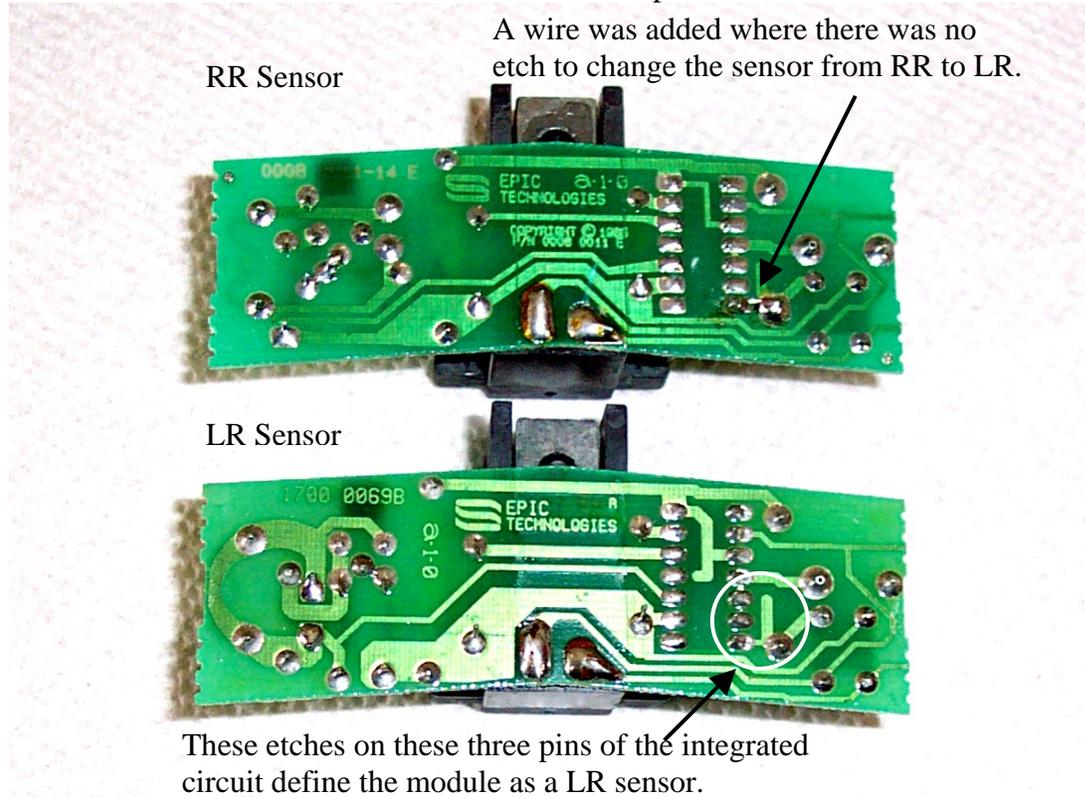
The sensor's wiring defines its location. RR, LR, LF and RF. This is determined by the etched connections on the circuit board. A sensor can be modified to function in another sensor location. For example a RR sensor can be modified to function as a LR sensor if the circuit board etch is modified. Here is an example of a modification.

The receiver module on a '92 car can be used to verify that the modification was performed correctly. The '92 receiver can identify which module is signaling a low tire pressure condition. The codes are 23 for the RR, 33 for the LR, 43 for the LF and 53 for the RF. The '91 service manual lists these low tire pressure codes for the '91 cars. However they don't function on a '91.
