THE TECHNICAL EVOLUTION OF THE ZR-1

Are the '95 models really that much
better?

MAJOR CHANGES TO LT5

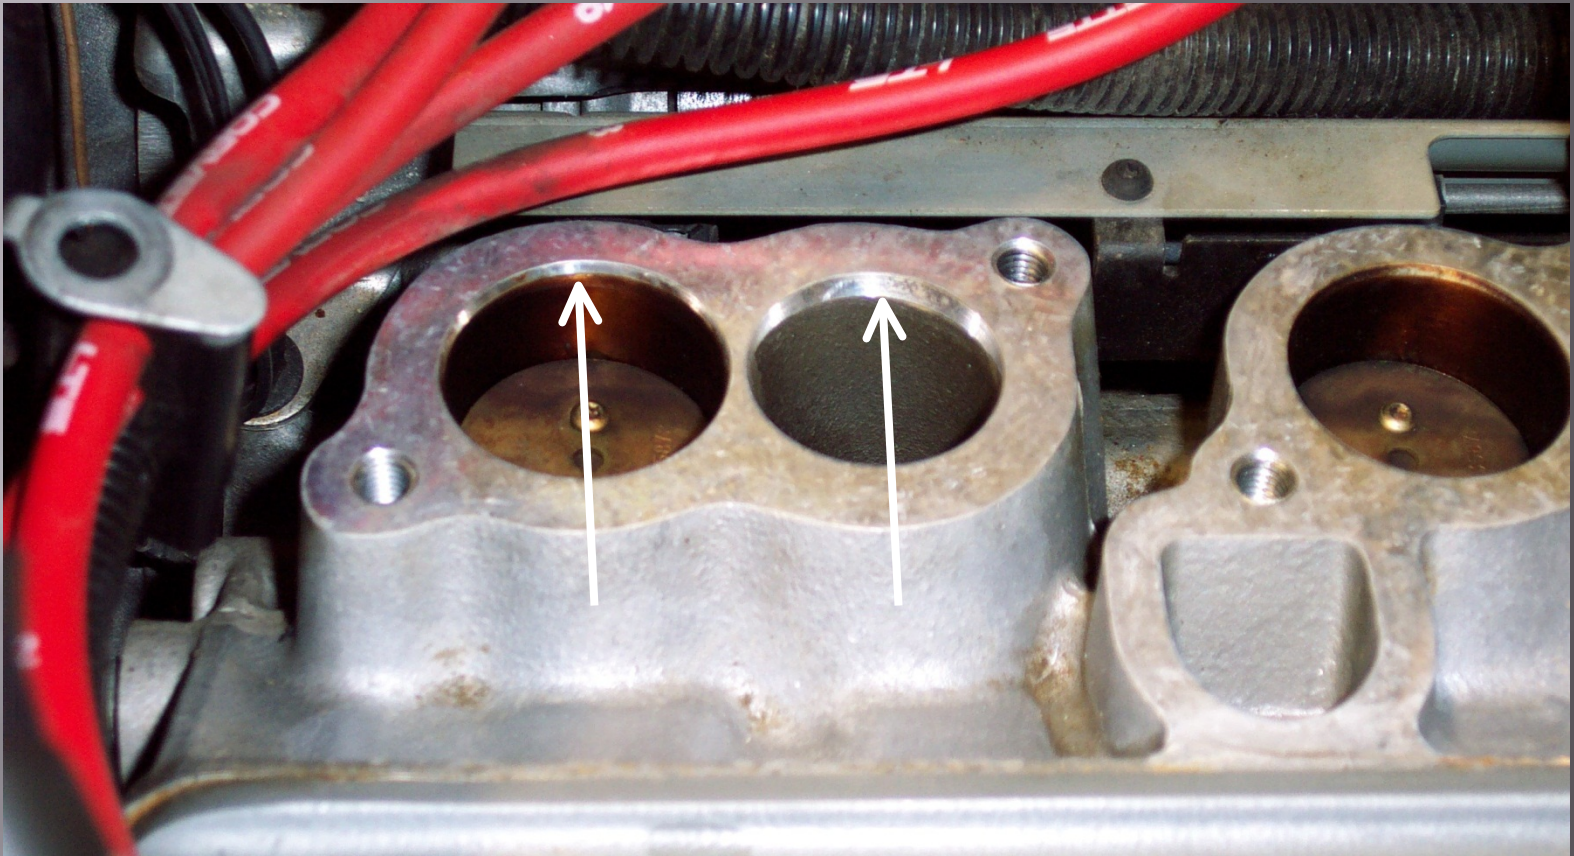
Cylinder head to injector housing port mismatch on a '91.

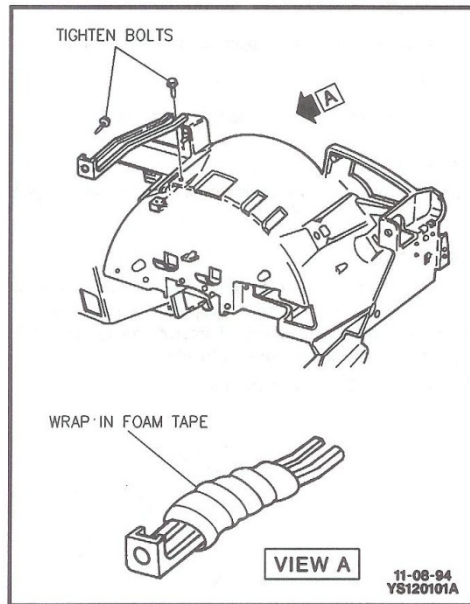
Figure 19 - Instrument Panel - Support Bracket

Buzz or rattle at driver's side of instrument panel (I/P).

Loose instrument panel upper support bracket bolts and/or support bracket contacting upper trim pad or I/P.

Tighten bolts. Wrap bracket in foam tape. See SECTION 8C for upper trim pad removal.

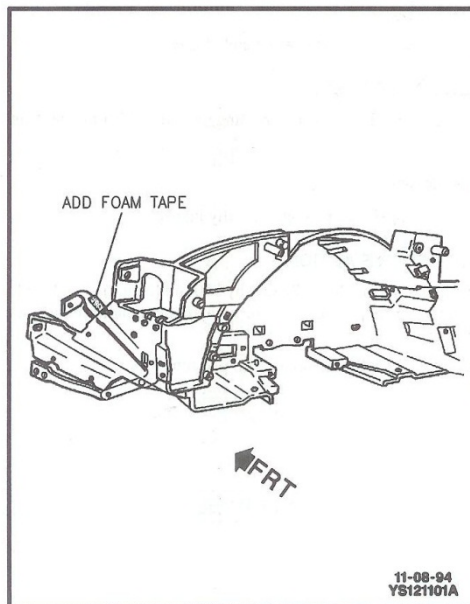
Figure 20 - Instrument Panel - Outer Knee Bolster Bracket

Rattle at left side of instrument panel (I/P).

Driver's knee bolster outer bracket contacting HVAC air duct.

Wrap knee bolster outer bracket with foam tape at area of contact.

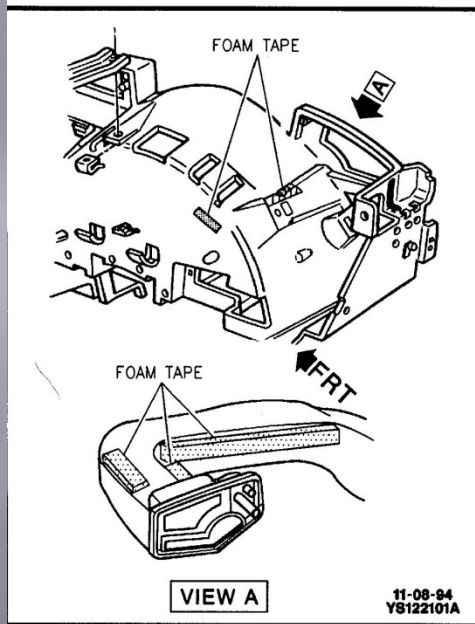
Figure 21 - Instrument Panel - Air Distribution Duct - LH

Rattle at top of instrument panel near I/P cluster.

A/C air distribution rattling on top of instrument panel.

Pull up on the air distribution duct and install a 1/8 inch thick foam tape insulator to the instrument panel and air duct in area of contact.

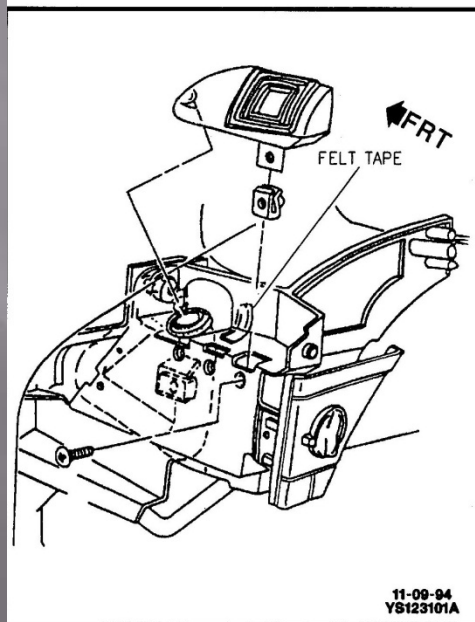
Figure 22 - Instrument Panel - Side Window Defogger Outlet

Buzz coming from left side of instrument panel.

Side window defogger duct outlet buzzing on instrument panel.

Remove instrument panel upper trim pad and side window defogger duct outlet. Install 1/2 inch by 3 inch section of felt tape to the instrument panel where shown.

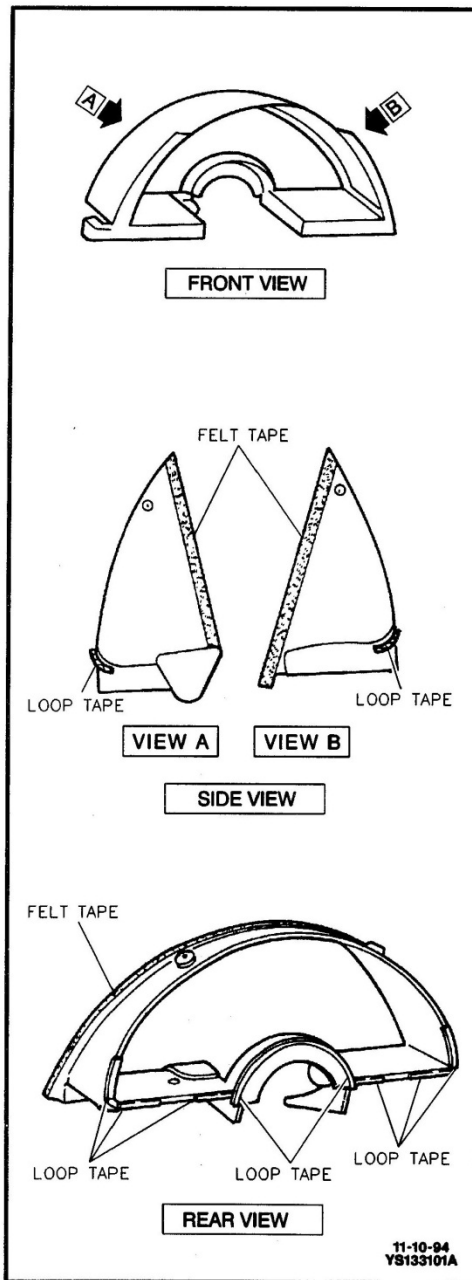
Figure 31 - Instrument Panel - Cluster Trim Plate

Squeak, rattle, buzz, itch from instrument panel (I/P) cluster

- Cluster trim plate contacting I/P.
- Cluster trim plate contacting cluster.
- Other possible causes with repair headings in quotes:
 - Cluster trim plate contacting "Headlamp switch."
 - Cluster trim plate contacting "Door Trim Panel at I/P."
 - "Cluster Lens" contacting I/P.

Remove cluster trim plate.

- Install loop portion of hook and loop tape in 50mm (2 in) long strips to rear of trim plate as shown in rear view.
- Install loop tape around steering column opening as shown in rear view.
- Install felt tape behind front upper edge of trim plate shown in side and rear views.
 - Install tape just up to the edge so that it does not show when trim plate is installed.

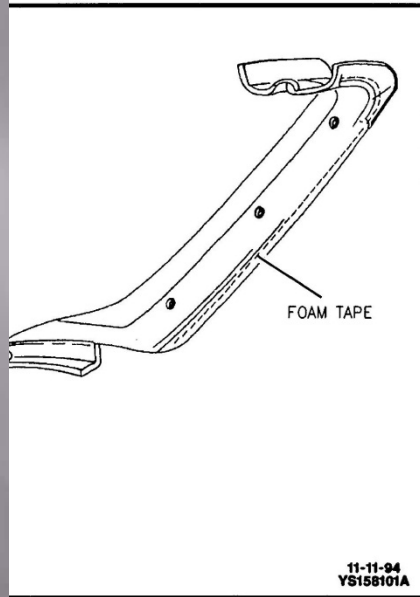
Figure 57 – Roof – A-Pillar Moldings

Itch coming from A-pillar.

A-pillar garnish molding contacting A-pillar weatherstrip.

Remove garnish molding and install foam tape to inside of outer lip along entire length of molding.

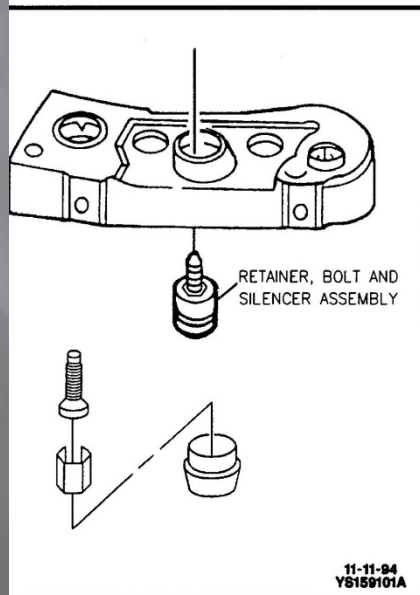
Figure 58 – Roof – Hold-Down Bolts

Jingle coming from top corner of windshield with roof panel or convertible hardtop removed.

Front hold-down captive bolt loose in retainer.

Replace bolt, retainer, and silencer.
