Finding and Fixing Vacuum Leaks on the LT5 Engine

Marc Haibeck

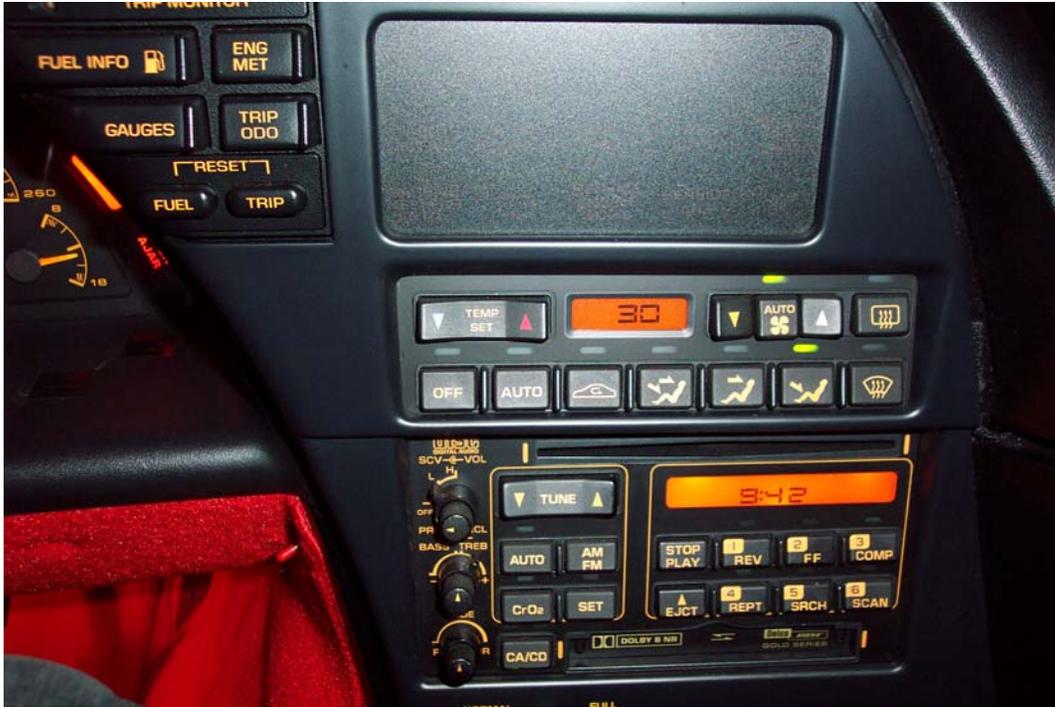
The 30 in the display represents 750 rpm. $30 \times 25 = 750$ rpm.

Check if the tachometer is displaying the correctly. It often fails such that the displayed rpm is too high. The digital engine rpm from the engine control system can be shown on the HVAC LCD display. Press the fan up and down arrows together until -00 is displayed. Then press the fan up button until -06 is displayed. Finally, press the fan button (located between the fan up and down buttons) one time. The number displayed x 25 = the engine speed.

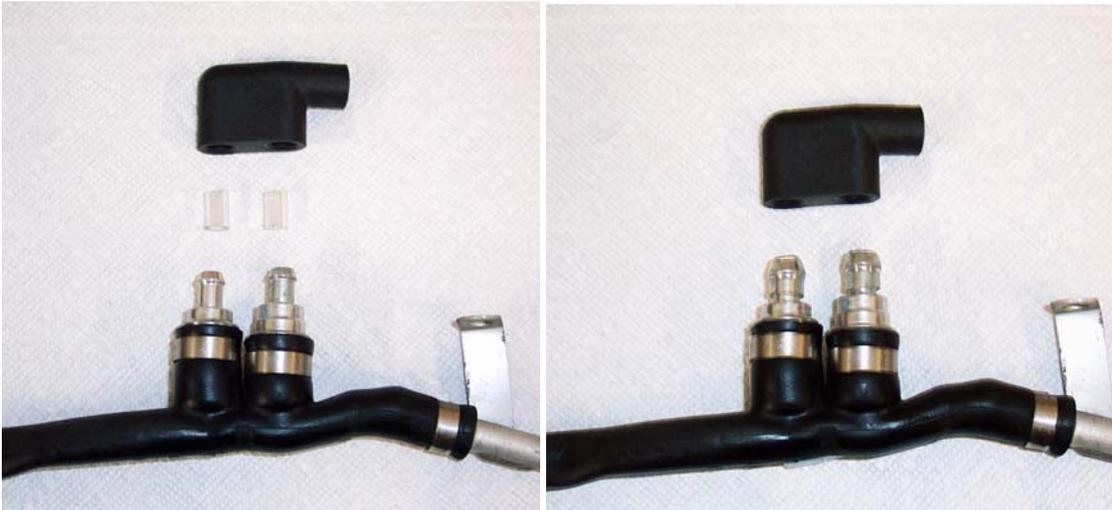
1. The PCV valve grommet. Like several other rubber parts on the engine, the grommet swells from long-term exposure to oil. Then it fits loose on the PCV valves. The grommet is available from Jerry's Gaskets, pn 10153503. The grommet will fit tightly again if the PVC valves are sleeved.

To sleeve the valves, slip short stubs of ¼" vinyl tubing on the nipples. Secure the grommet to the PCV tube with a ¼" wide worm gear clamp just as GM did beginning in '93. Install a plastic tie to hold the grommet down. Clamp it lightly so that the hose that the PCV valves are mounted on does not get crimped at the bottom.

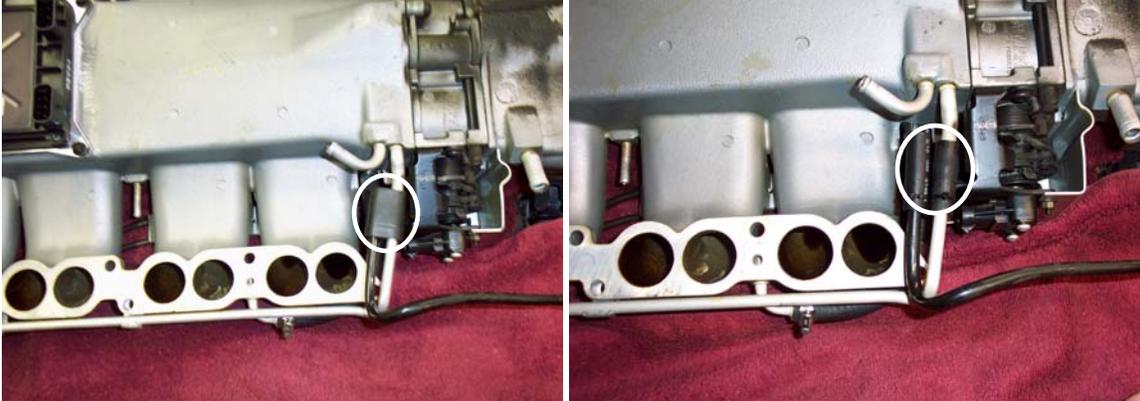
2. The dual vacuum fitting on a '90. Sometimes this fitting whistles while leaking. It's shown here on a '91 plenum for illustration. It is not available from a supplier. It's easy to replace it with two sections of 5/16" fuel line that are two inches long.

Bend the front tube forward a little to create some space between the tubes. Lubricate the ID and OD of the hose and slip it on the plenum. It fits very tight and does not need a clamp. Slip the two vacuum lines in the hoses and clamp them with plastic ties.

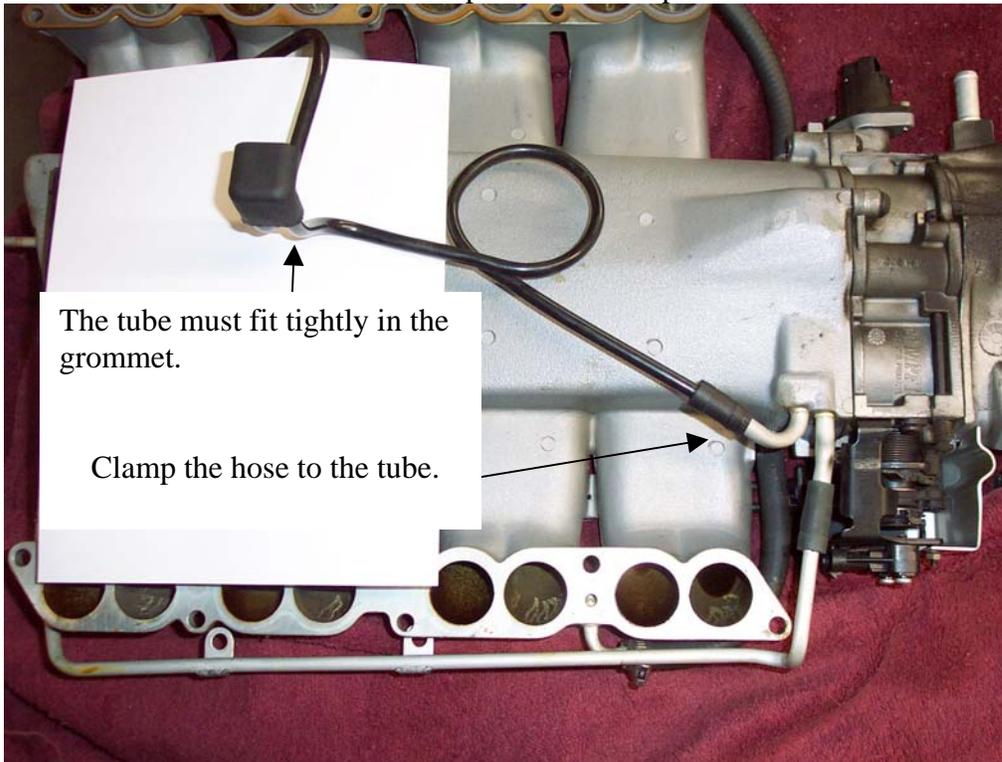
3. The Evaporative Emissions hose on '91 and up. This hose can blow off the plenum or the valve grommet if the engine backfires. If either end comes off, there will be a large vacuum leak. It will add about 800 rpm to the idle speed.

The '91's have the most problems with this because the hose was not clamped. For '92-'95 GM added a clamp. The hose can be clamped with a plastic wire tie. The end that connects to the valve grommet can be reattached with the adhesive described below for the MAP hose.

The hose and tube ends can be reattached without removing the plenum if one is skilled and a little lucky with a wire formed with a hook.

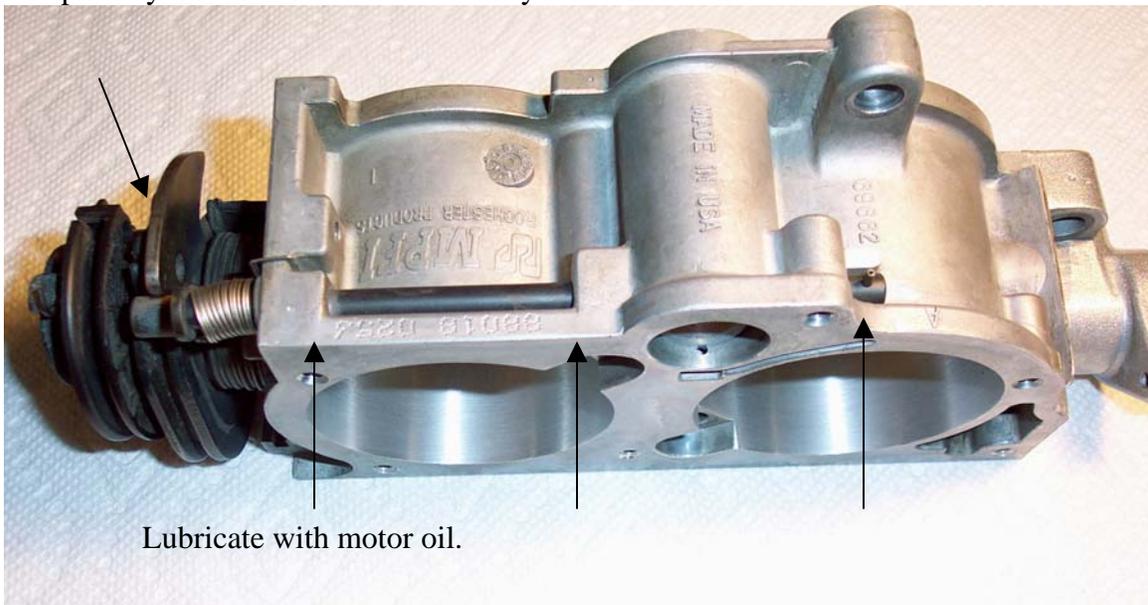
The primary throttle shaft can have sticky rotation. It can be cleaned and lubricated.

Lubricate with motor oil.

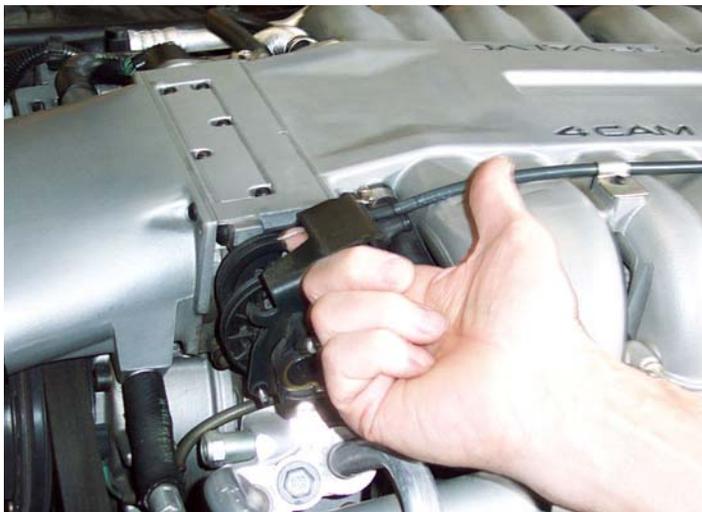
On '92-'95 cars the throttle cable could be too tight and hold the throttle off the idle stop. There should be little slack in the throttle cable. Check it with a finger.

The cable can be loosened with the adjuster. Wrap tape on the cable 1/8" away from the body of the adjuster. Press the release button on the adjuster so that the 1/8" gap is closed. Check that there is now slack in the cable and that the throttle arm cleanly goes to the stop. This adjustment interacts with the cruise cable. If the cruise cable is too tight loosen it by one hole. Loosening the throttle cable also interacts with the wide-open throttle position. The throttle probably won't go to 100% open. It's no problem as long as it is at least 96%. There is little difference in airflow from 96 to 100% opening.

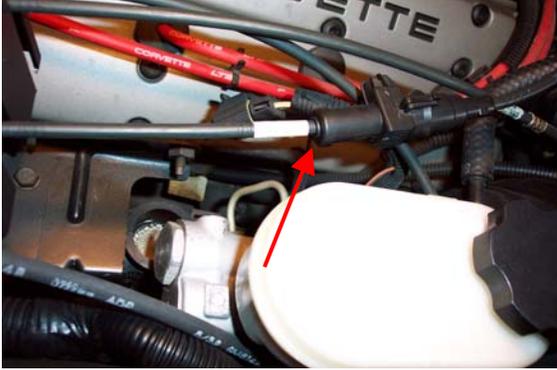
Note the 1/8" gap.

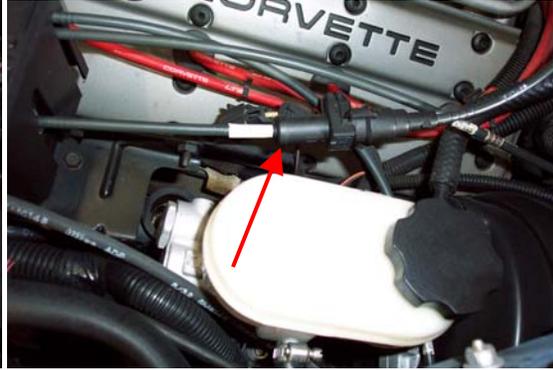
Close the gap. The tape is now adjacent to the adjuster.

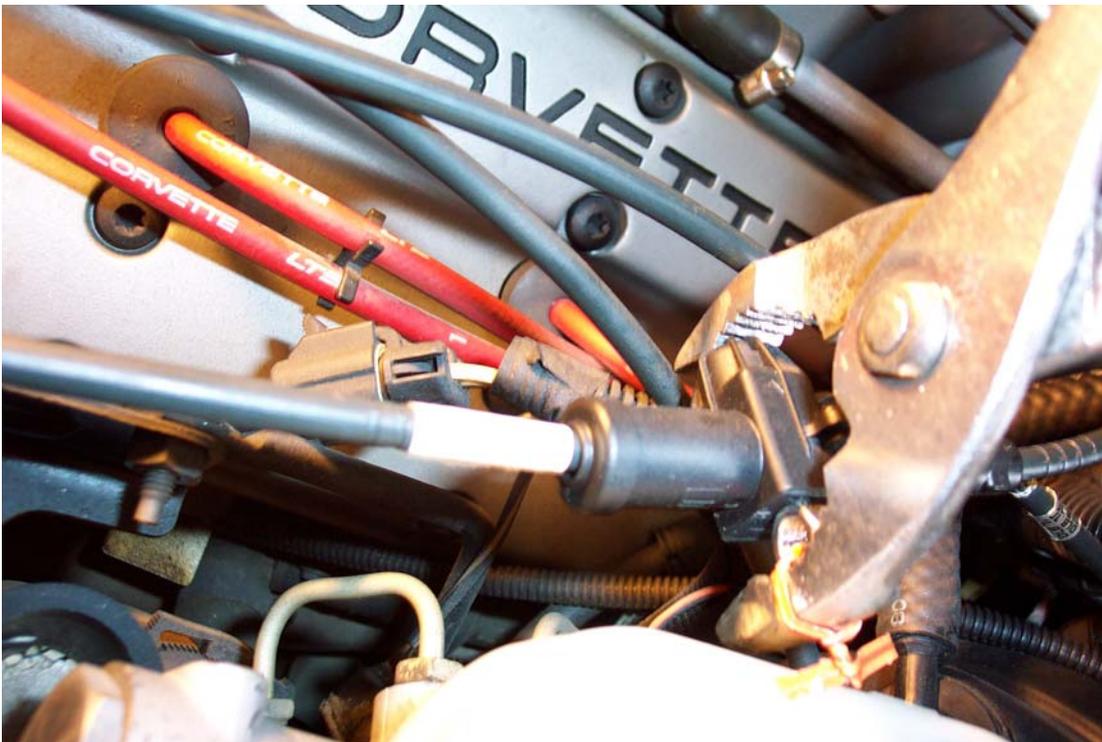
Depressing the cable length adjuster. The button is the flat section.

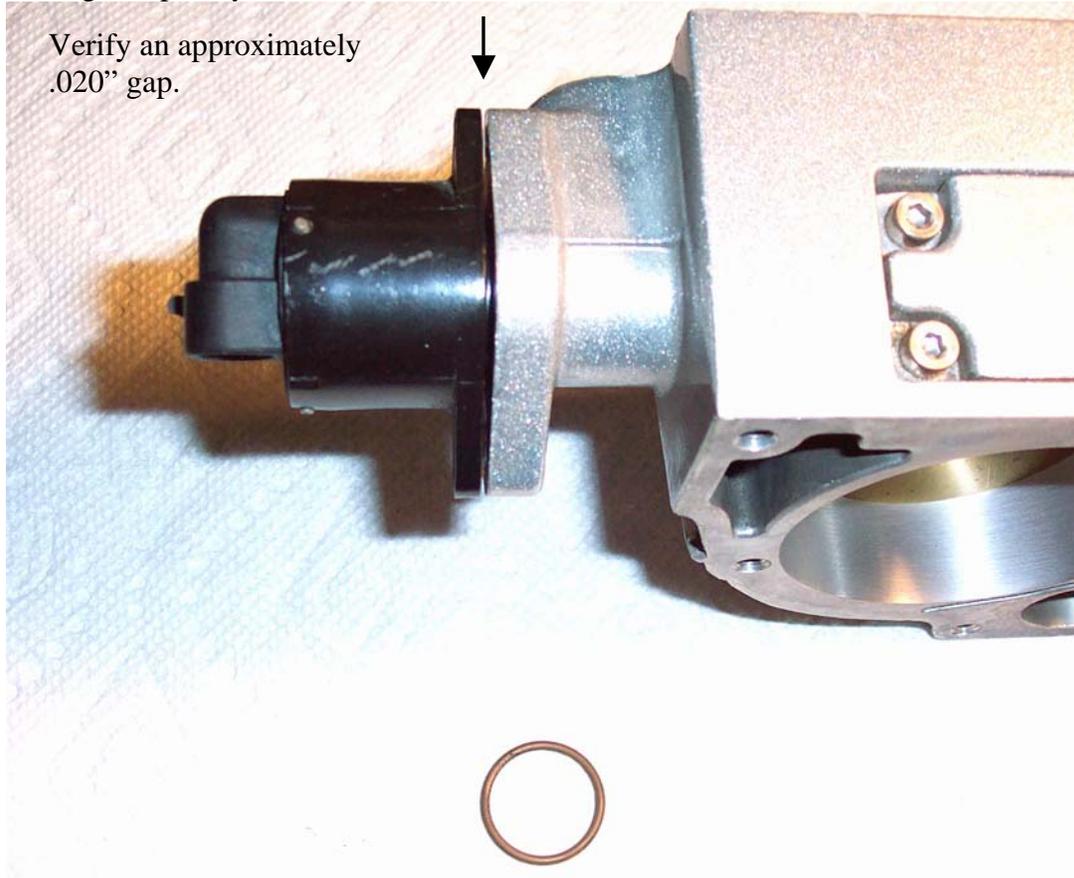
Verify that the IAC valve is fully closing. With the engine idle speed out of control remove the electrical connector from the IAC valve. Shut the engine off. Remove the IAC valve. Remove the o-ring from the valve. Reinsert the valve in the throttle body.

Verify that the body of the valve springs back about .020". This confirms that the valve is closing completely.

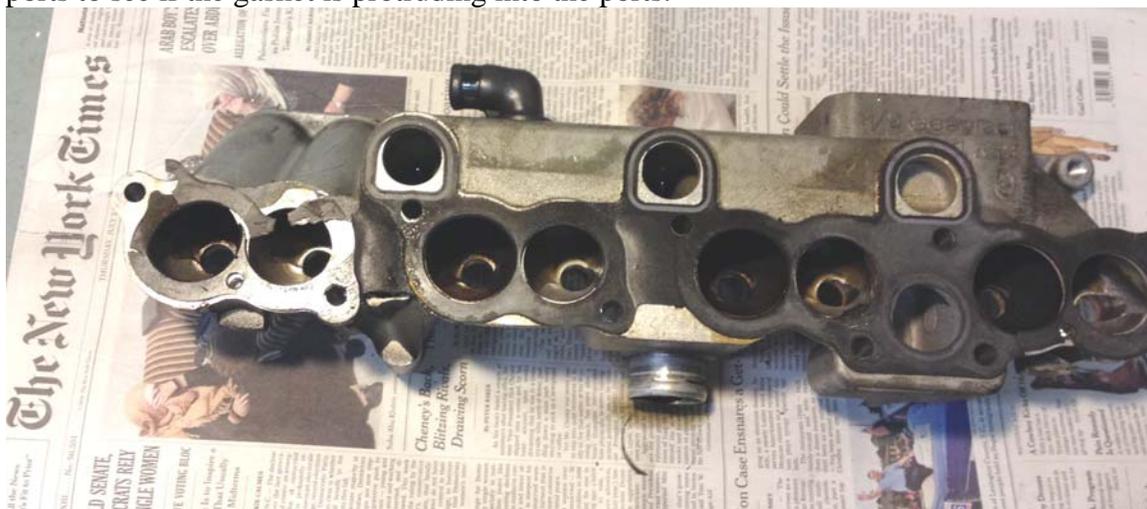
5. Injector housing gasket failure. This is more likely to occur on '93-'95 engines. The injector housing and plenum gaskets were revised with different material to address a shrinkage problem. This might have made them more prone to tear. Look down the intake ports to see if the gasket is protruding into the ports.

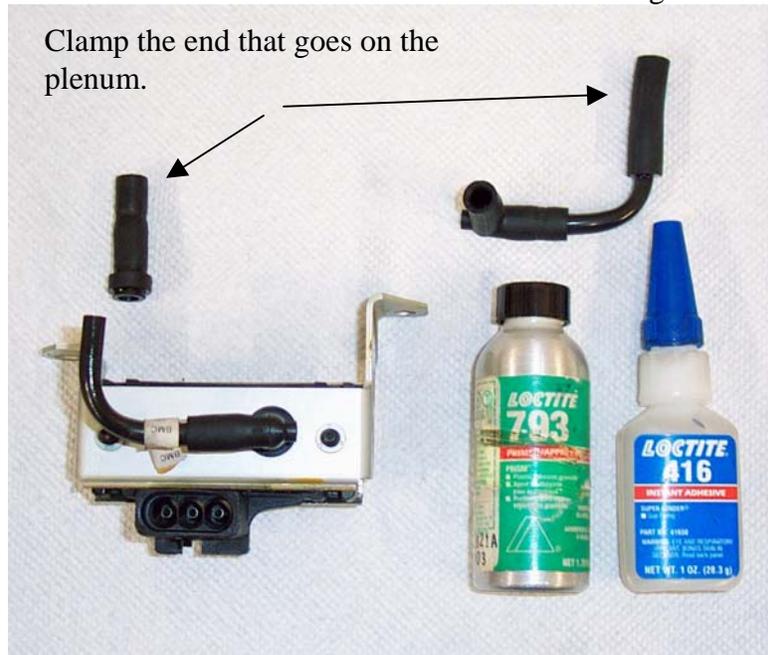
6. The MAP sensor hose. The rubber end that attaches to the plenum swells and becomes loose. It often separates from the plastic hard line during a backfire. The picture shows the underside of the sensor. The hose can be accessed from the right side of the engine.

If the rubber end is not too loose, it can be reattached with adhesive. Or it can be replaced with a section of 3/16" vacuum hose. Loctite 416 is similar to the OE adhesive. Loctite 793 is a primer for the adhesive. The primer must dry completely before applying the adhesive. The adhesive sets up in about one second. Be careful not to clog the tube with adhesive. To be safe, apply the adhesive to the outside of the tube, not inside the connector. Check the hose for free flow after the repair is complete.

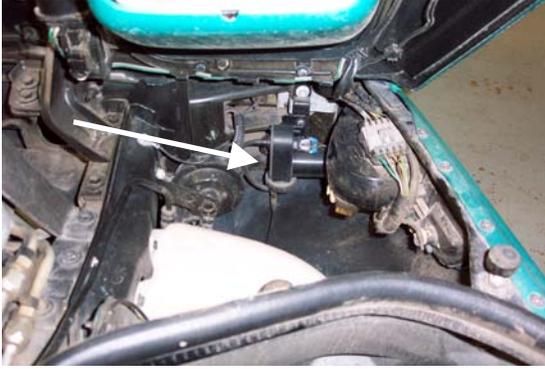
The secondary intake port vacuum pump should run for a few seconds and shut off for at least one second after first turning on the ignition switch but not starting the engine. If it is silent it may not be operational. Remove the plastic vacuum hose from the pump. The pump should then run continuously. If the pump does not run, check for 12 volts at the pump connector. If power is not present check the fuse. On '90 -'92 cars the fuse is located on the left wheelhouse. See the picture below. On the '93 - '95 cars the fuse is in the panel at the right door. Fuse 17, labeled as the Valet Fuse.

The pump is available from Jerry's Gaskets and AutoZone. The replacement pump has a '91- '95 connector. For a '90 car install connector GM pn 13586114.

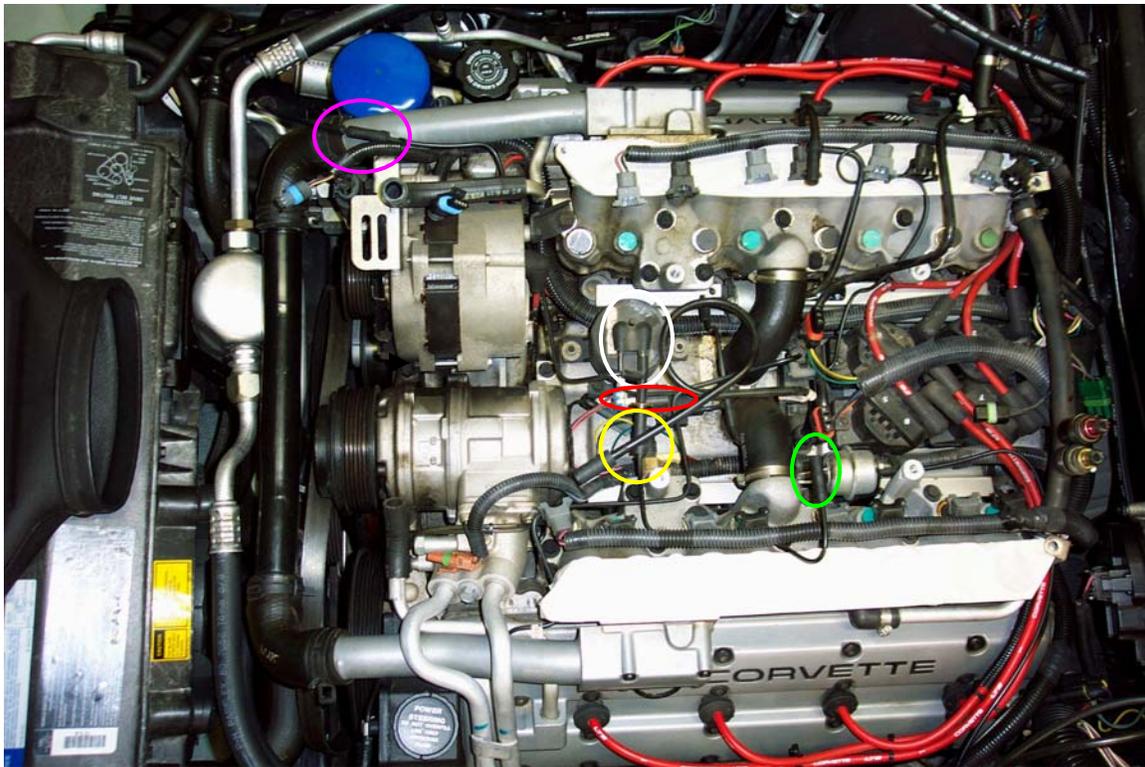
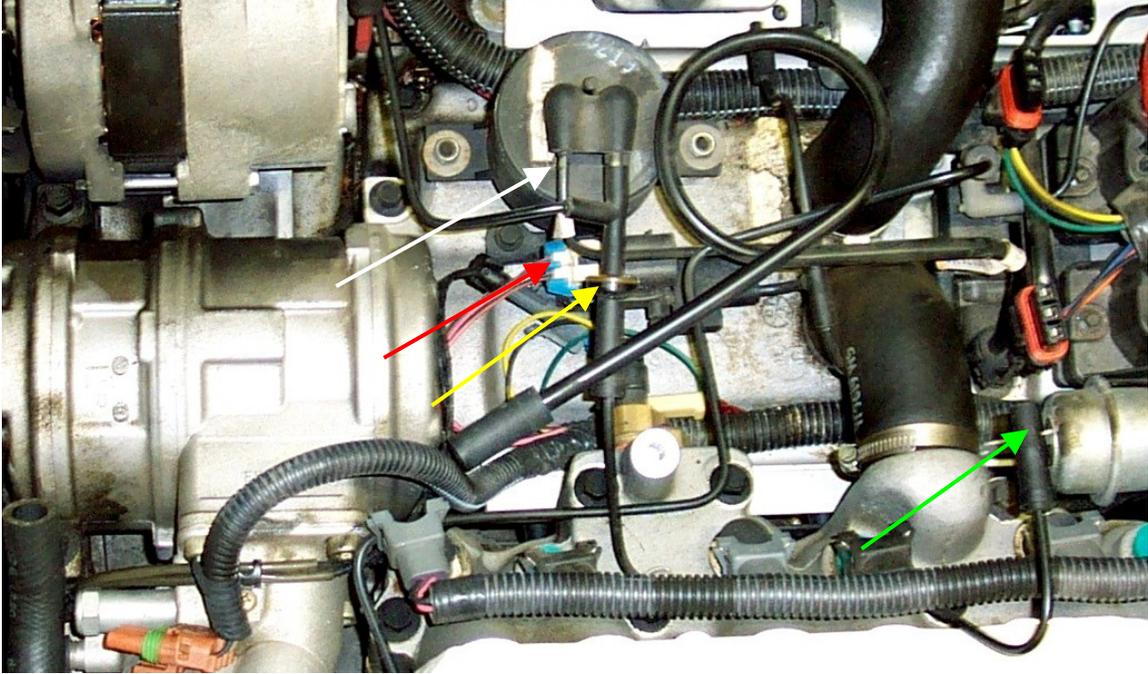
- In the pink circle. The secondary vacuum hose connector. This connector can easily pull apart if the engine compartment is serviced or cleaned. The connector ends rarely separate or leak. Sometimes they are impossible to separate. The tube end can separate or leak in the connector. The adhesive for the MAP sensor above can be used to repair it.

- In the yellow circle. The secondary vacuum check valve. See detail picture yellow arrow. To test the vacuum check valve, cover the plenum connector with a finger. The plenum connector is marked in green in the pictures. If the pump stays off longer, the valve is leaking. For '90 - '92 cars the valve is available from Jerry's Gaskets pn 14047619. For '93 -'95 use Jerry's 14056648.

- In the white circle. The secondary vacuum reservoir. See detail picture white arrow. The connection to the "T" fitting connection from the vacuum pump is the most common leak. The adhesive for the MAP sensor above can be used to repair it.

- In the red circle. The secondary vacuum solenoid. See detail picture red arrow. Remove the connector from the valve and block the port from the pump with a finger. If the pump stays off longer, the valve is leaking. The valve is available from Jerry's Gaskets. PN 1997212.

The secondary vacuum pump cycle time can be used as a diagnostic to locate leaks. If the pump can cycle off for one second the vacuum connections are tight enough for the secondary port throttles to operate correctly. There are four common leakage points in the vacuum lines before the secondary solenoid vacuum valve.

Turn the ignition on without the engine running. With the vacuum pump either running continuously or cycling check for evidence of a vacuum leak by listening for a change in the vacuum pump operation.

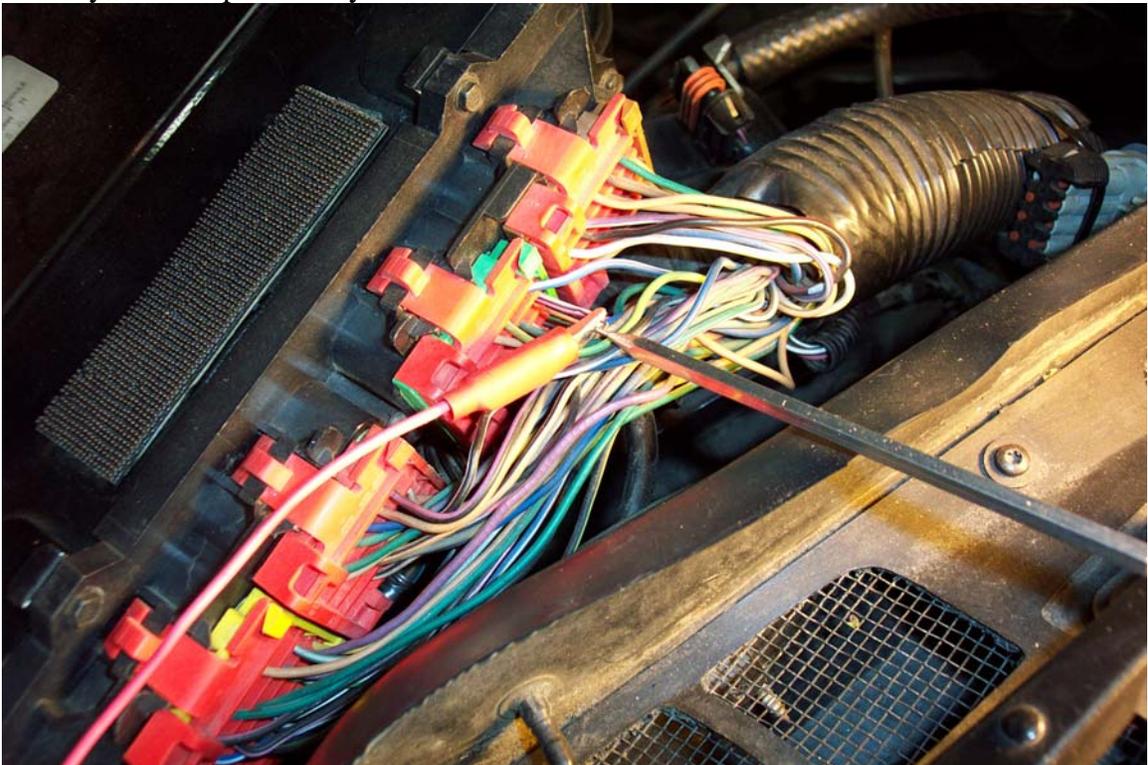
After determining that the vacuum connections are tight before the vacuum solenoid valve, test the connections after the valve. The valve can be opened by grounding pin C17 at the ECM. The “C” connector is the green ECM connector. The pin locations are marked on the connector in very small print. The wire is pink with a black stripe on all model years except for early ‘90’s where it is red.

Slip the pin probe under the wire’s sealing ring and touch the pin. When pin C17 is grounded, the pump will run and the secondary port throttles will open. The pump will
