Verifying Secondary Actuator Operation with the Plenum in Place

Marc Haibeck

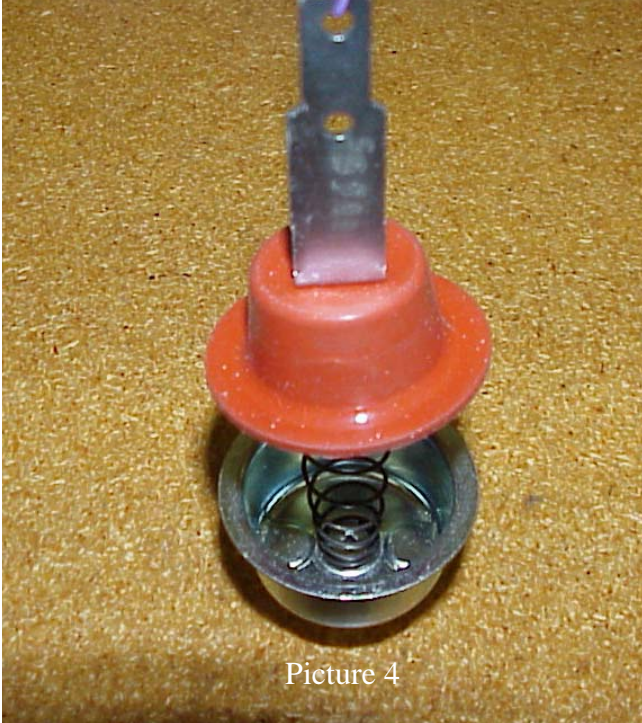
Picture 4 shows the normal position of the return spring.

It should be centered on the cone on the end of the cover.

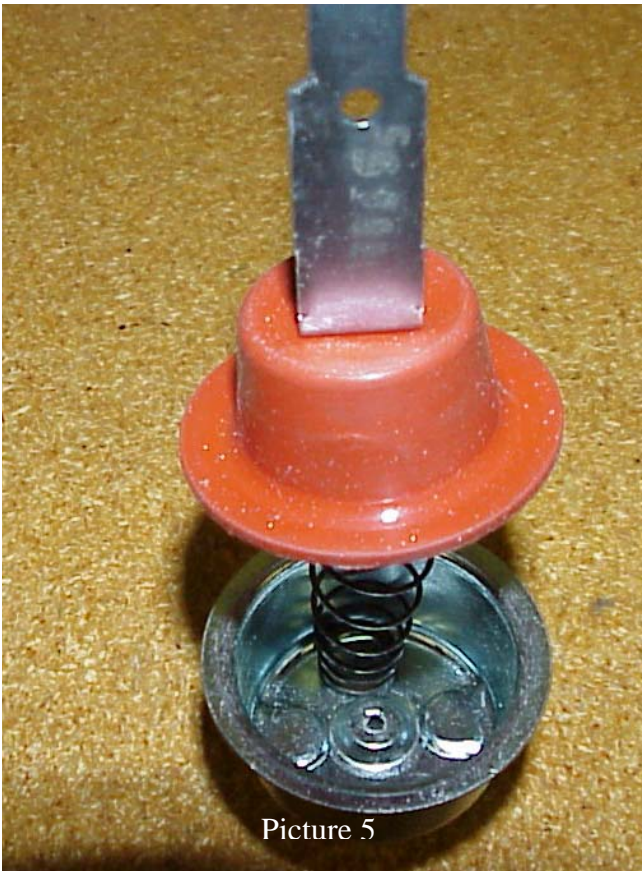
Picture 5 shows the position of the spring, if the unit is improperly assembled.

The defective actuators are assembled in such a way that the spring is off to the side. They will activate, but additional vacuum is necessary to crush the spring sideways at the end of the travel.

The GM service parts operation ran a production run of actuators in the Spring of 2001. Some of the new actuators have been found to be defective. Normally, an actuator will fully retract with 6" Hg. vacuum. The defective parts will require in excess of 10" Hg. vacuum. Also, defective units will twist the arm to the side as they pull in.

The actuators can be identified by the date code that is printed on the arm. The units dated April and May of 2001 may have the defect. As of September 2001, the new parts can also be identified by the red material that is used for the vacuum diaphragm. These units should be tested before installation. It seems like about 1/2 of them were assembled incorrectly.
